**Flood Control Project Maintenance
Levee Inspections**

Fall 2018 Levee Maintenance Deficiency Summary Report

Sacramento Maintenance Yard West Levee Yolo Bypass

Levee Inspection Report By Mile - Fall 2018

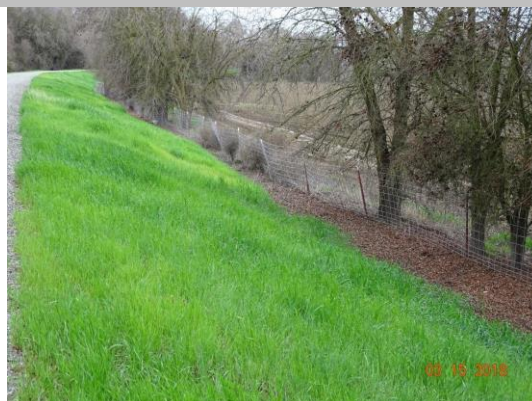
Photo 1 of 3 : FA_2018_ST0011_291_10_20180904_00005.jpg

LM Start	0.12	Rating **	M	Issue No.	10 (cont)
LM End	1.55	Issue Type +	En	Location *	LS

Updated view of fence at landside toe. Spring 2018.

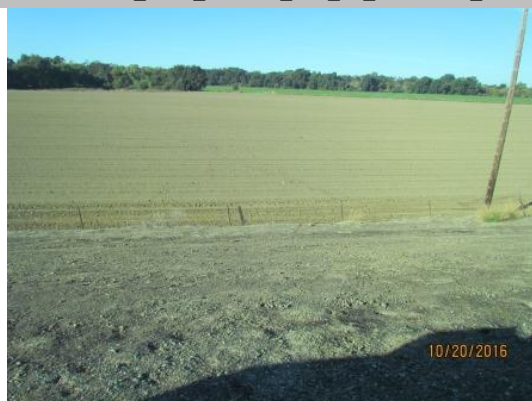
Photo 2 of 3 : FA_2018_ST0011_291_10_20180904_00006.jpg

View of fence located within 10-foot easement of landside toe. Fall 2016.

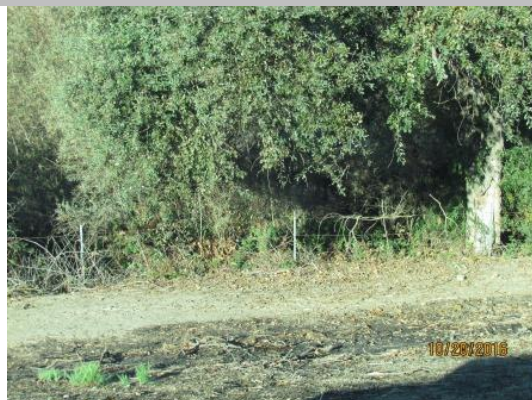
Photo 3 of 3 : FA_2018_ST0011_291_10_20180904_00007.jpg

LM Start	0.12	Rating **	M	Issue No.	10 (cont)
LM End	1.55	Issue Type +	En	Location *	LS

Another view of fence located within 10-foot easement of landside toe. Fall 2016.

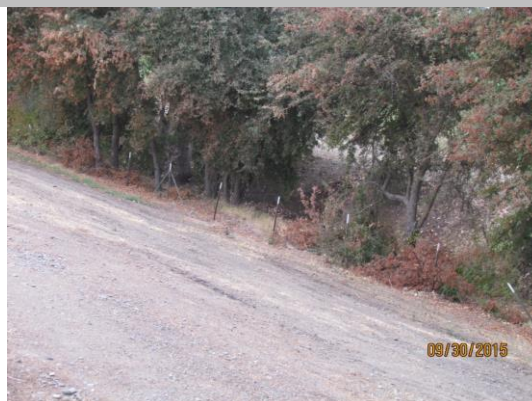
Photo 1 of 1 : FA_2018_ST0011_291_8_20180904_00002.jpg

LM Start	0.94	Rating **	M	Issue No.	8
LM End	1.83	Issue Type +	En	Location *	LS
Category	Earthen Levee			GPS Latitude/Longitude	
				Start	End
Item	Encroachments			38.747888 °	38.734972 °
				-121.660202 °	-121.660265 °
DWR ID	DWR_ST0011_01_s_2012_8				
Comment Code					
DT : Ditch					
Inspector Comment					
The ditch is at the toe of the levee.

View of the ditch on the landward side of the levee. Fall 2015.

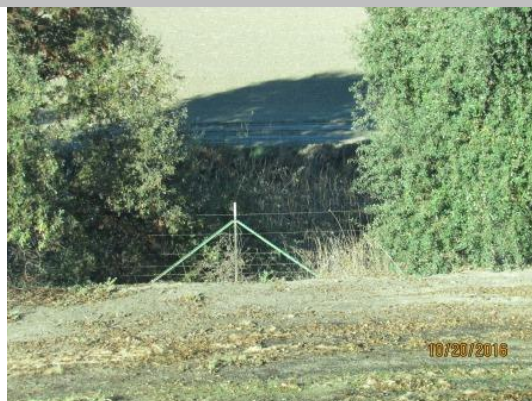
Photo 1 of 2 : FA_2018_ST0011_291_9_20180904_00003.jpg

LM Start	1.70	Rating **	M	Issue No.	9
LM End	1.79	Issue Type +	En	Location *	LS
Category	Earthen Levee			GPS Latitude/Longitude	
				Start	End
Item	Encroachments			38.736842°	38.735498°
				-121.660285°	-121.660287°
DWR ID	DWR_ST0011_01_f_2016_9				
Comment Code					
FE : Fence					
Inspector Comment

View of fence along the ditch on landside. Fall 2016.

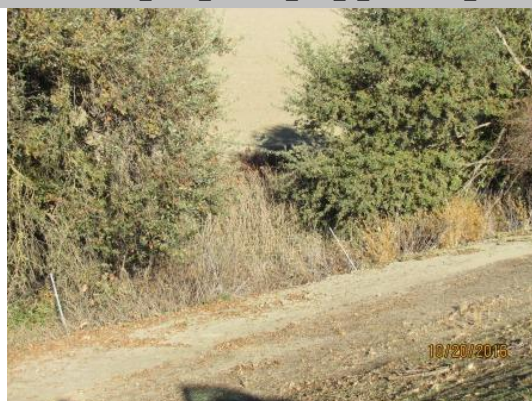
Photo 2 of 2 : FA_2018_ST0011_291_9_20180904_00004.jpg

LM Start	1.70	Rating **	M	Issue No.	9 (cont)
LM End	1.79	Issue Type +	En	Location *	LS

Another view of fence along the ditch on landside. Fall 2016.

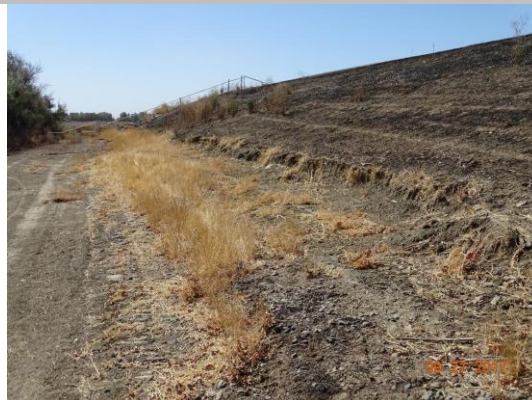
Photo 1 of 2 : FA_2018_ST0011_291_13_20180904_00008.jpg

Notes: This site had wave wash around a bend including on an access ramp. The site has been accepted for repair by USACE under PL84-99, but is a lower priority so will not be fixed before this flood season.

View of wave wash at waterside toe. Fall 2017.

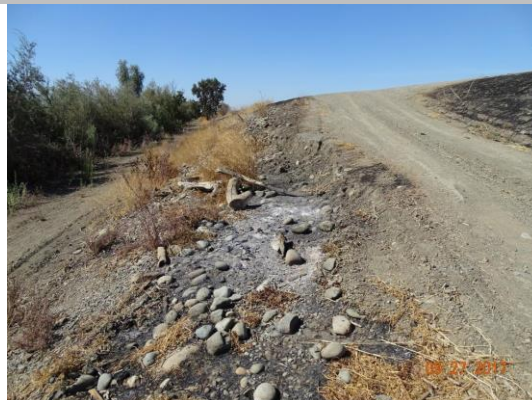
Photo 2 of 2 : FA_2018_ST0011_291_13_20180904_00009.jpg

View of wavewash on access ramp near waterside toe. Fall 2017.

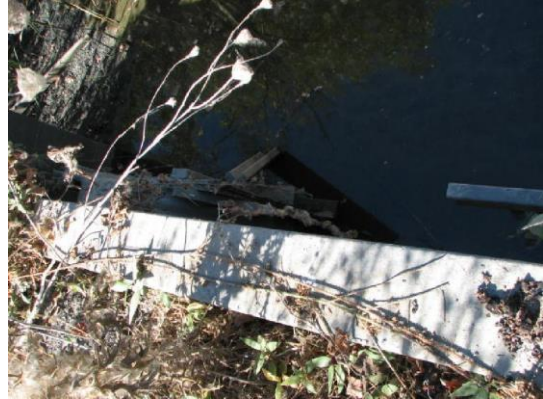
Photo 2 of 3 : UCIP_FA_2018_53233_60308.jpg

Landside view: concrete spill box

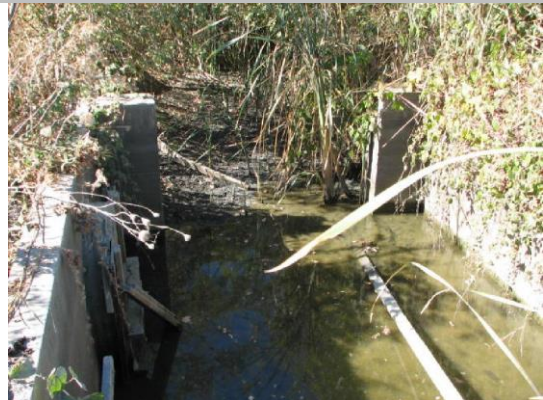
Photo 3 of 3 : UCIP_FA_2018_53233_60307.jpg

Landside view: CM pipe with flap gate

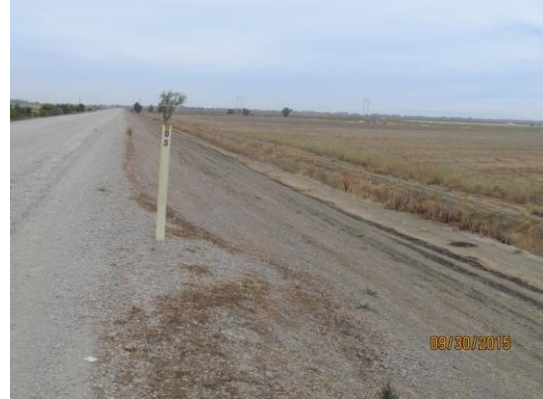
Photo 1 of 3 : FA_2018_ST0011_292_3_20180904_00001.jpg

LM Start	0.47	Rating **	M	Issue No.	3
LM End	0.97	Issue Type +	En	Location *	LS
Category	Earthen Levee			GPS Latitude/Longitude	
				Start	End
Item	Encroachments			38.712813 °	38.706018 °
				-121.667349 °	-121.670831 °
DWR ID	DWR_ST0011_02_s_2012_3				
Comment Code					
DT : Ditch					
Inspector Comment					
Ditch was deepened to approximately 10 ft.

View of the ditch at the landward side of the levee looking downstream.
Fall 2015.

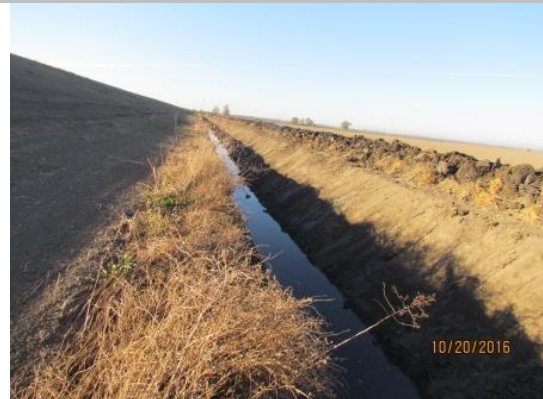
Photo 2 of 3 : FA_2018_ST0011_292_3_20180904_00002.jpg

View of the ditch on landward side. Ditch was deepened to approximately 10 ft. Fall 2016.

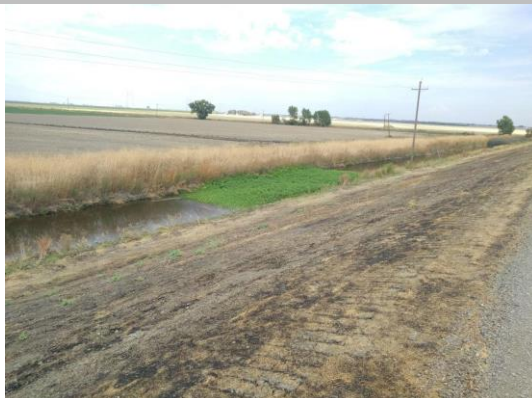
Photo 1 of 2 : FA_2018_ST0011_292_5_20180904_00004.jpg

LM Start	1.01	Rating **	M	Issue No.	5 (cont)
LM End	1.44	Issue Type +	En	Location *	LS

View of ditch at landside toe, looking upstream. Fall 2017.

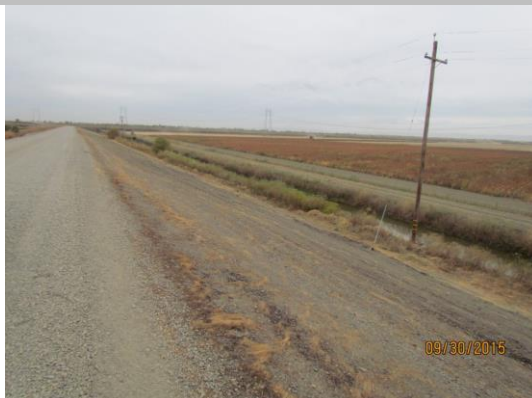
Photo 2 of 2 : FA_2018_ST0011_292_5_20180904_00005.jpg

View of the ditch on the landward side of the levee looking downstream. Fall 2015.

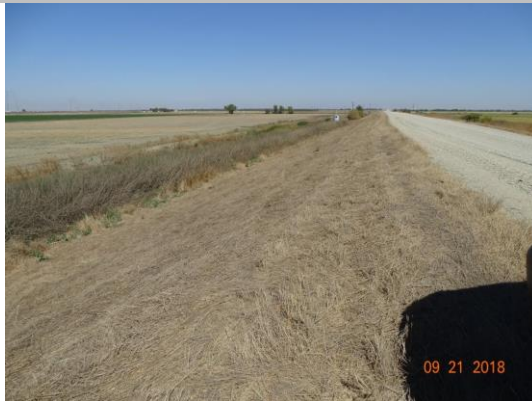
Photo 1 of 1 : FA_2018_ST0011_292_1_20180924_00006.jpg

LM Start	1.43	Rating **	A	Issue No.	1
LM End	1.43	Issue Type +	Ma	Location *	LS
Category	Earthen Levee			GPS Latitude/Longitude	
				Start	End
Item	Vegetation			38.699928 °	38.699928 °
				-121.674070 °	-121.674070 °
DWR ID	DWR_ST0011_02_f_2018_1				
Comment Code					
V1 : Control annual grass and weeds on the levee slopes and easements.					
Inspector Comment					
Sac Yard maintains the vegetation at a high level.

View of the mowed landside slope. Fall 2018.

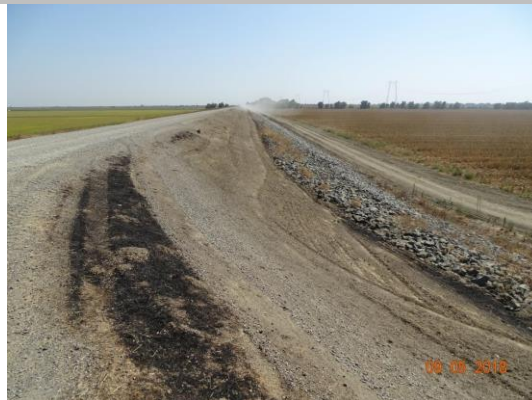
Photo 1 of 1 : FA_2018_ST0011_293_2_20180905_00004.jpg

View of the recently burned and dragged landside slope. Fall 2018.

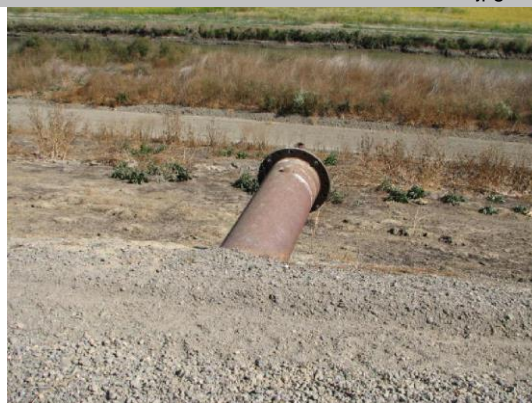
Photo 1 of 3 : UCIP_FA_2018_53252_60378.jpg

LM Start	0.03	Rating **	M	Issue No.	3
LM End	0.03	Issue Type +	En	Location *	
Category	Supplemental			GPS Latitude/Longitude	
				Start	End
Item	DWR UCIP Field Study			38.698204 °	38.698204 °
				-121.674080 °	-121.674080 °
DWR ID	17756				
Comment Code					
Inspector Comment					
FS_ID:53252					
DS_ID:17756					
EP_NO: N/A					
Repair Type: Non-Urgent					
Crossing Status: Found					
UCIP Comments: Pipe not properly abandoned.					
FIELD_STRUCT_DESC: *ABANDONED* 18-inch steel irrigation or drainage pipe through the levee, 3 feet below the crown.					
FS Date: 11/21/2018 8:24:23 AM

Waterside view: an abandoned steel pipe.

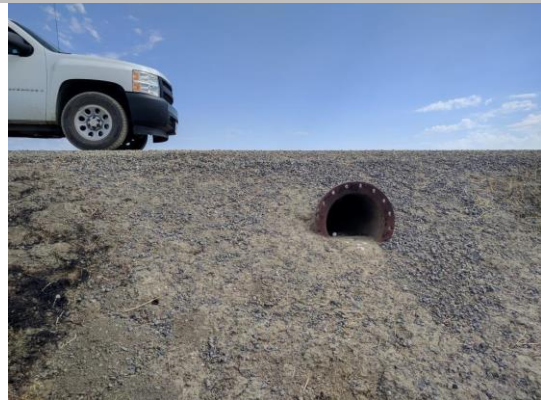
Photo 3 of 3 : UCIP_FA_2018_53252_77496.jpg

LS: straight through pipe without any gates preventing water from WS to LS.

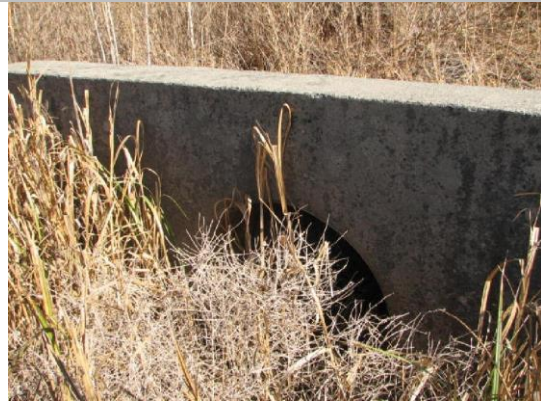
Photo 1 of 3 : UCIP_FA_2018_44826_60517.jpg

LM Start	0.60	Rating **	A/W	Issue No.	20
LM End	0.60	Issue Type +	Ma	Location *	
Category	Supplemental			GPS Latitude/Longitude	
				Start	End
Item	DWR UCIP LMA Responsibility			38.565704 °	38.565704 °
				-121.638650 °	-121.638650 °
DWR ID	528				
Comment Code					
Inspector Comment					
FS_ID:44826 DS_ID:528 EP_NO: 10304 Repair Type: No Action Needed Crossing Status: Found UCIP Comments: FIELD_STRUCT_DESC: 30-inch corrugated metal gravity drainage pipe through the levee, 22 feet below the crown. Flap gate on the waterside (WS) end. (30-inch pipe [HLM 0.59] authorized under Automatic Board Order (ABO) issued as Permit No. 10304, 1974 - Southern Pacific Transportation Company). [Additional Reference(s): DWR Levee Log, 2004. USACE Sacramento O&M Manual 120, June 1952, (Station 446+08)]. FS Date: 4/28/2015 2:58:55 PM

Landside view: concrete headwall.

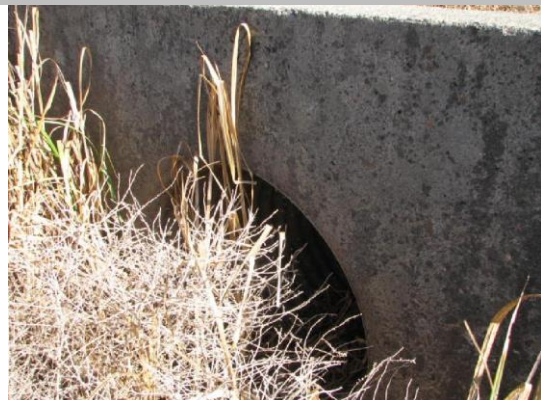
Photo 2 of 3 : UCIP_FA_2018_44826_60516.jpg

Landside view: closer look at the headwall.

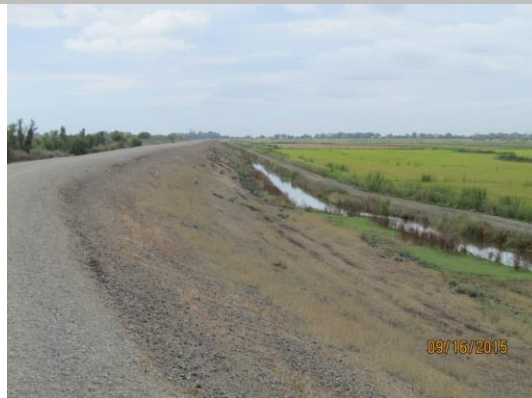
Photo 1 of 1 : FA_2018_ST0011_294_3_20180904_00001.jpg

View of the ditch along the levee toe on the landward side of the levee looking downstream. Fall 2015.

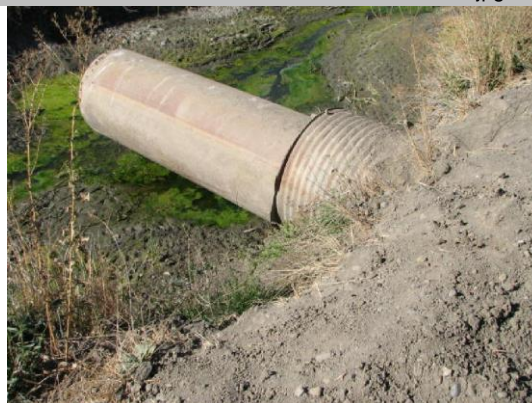
Photo 1 of 3 : UCIP_FA_2018_44822_24980.jpg

Comment Code					
Inspector Comment					
FS_ID:44822					
DS_ID:17736					
EP_NO: 10306					
Repair Type: No Action Needed					
Crossing Status: Found					
UCIP Comments: Farmer cleans this screw gate every year					
FIELD_STRUCT_DESC: 48-inch corrugated metal gravity drainage pipe through the levee, 21.5 feet below the crown. 42-inch steel pipe inside the 48-inch pipe. Flap gate on the waterside (WS) with two cutoff walls, one headwall, and one saddle and apron. (48-inch pipe [HLM 2.12] authorized under Automatic Board Order (ABO) issued as Permit No. 10306, 1974 - Wells Fargo Bank, Trustees for Cowell Foundation). [Additional Reference(s): USACE Sacramento O&M Manual 119, December 1952, (Station 80+00)].					
FS Date: 4/28/2015 2:57:49 PM

Landside view: 42-inch steel pipe inside a 48-inch CMP

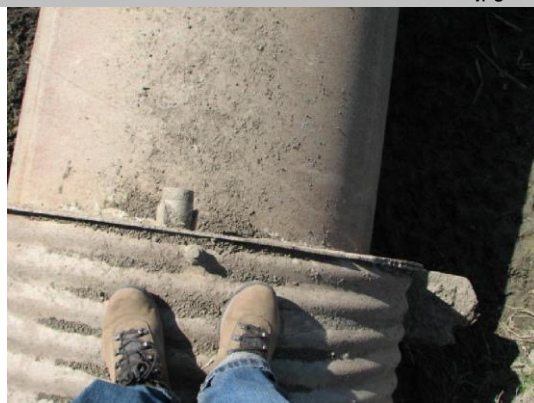
Photo 2 of 3 : UCIP_FA_2018_44822_24979.jpg

Landside view: closer look at 42-inch steel pipe and 48-inch CMP

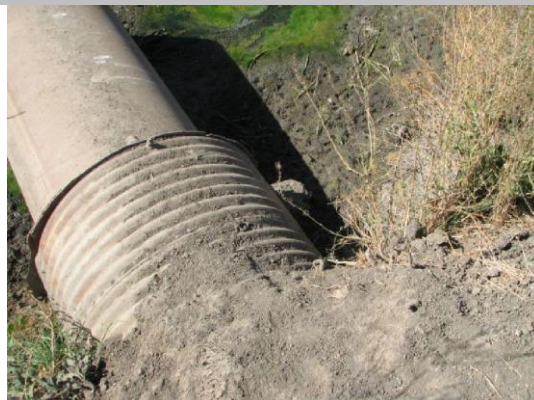
Photo 3 of 3 : UCIP_FA_2018_44822_24978.jpg

Landside view: closer look at 42-inch steel pipe and 48-inch CMP

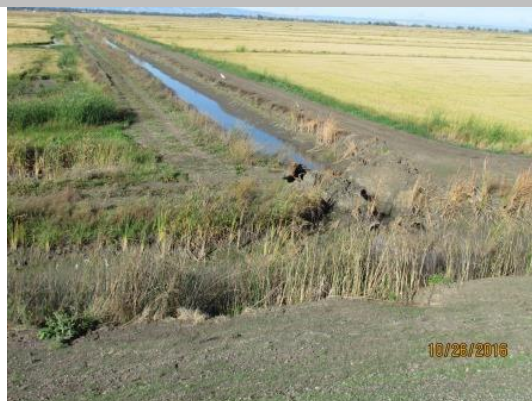
Photo 2 of 2 : FA_2018_ST0011_294_17_20180904_00006.jpg

LM Start	2.14	Rating **	A/W	Issue No.	17 (cont)	
LM End	2.14	Issue Type +	Ma	Location *	LS	
Category	Earthen Levee			GPS Latitude/Longitude		
				Start		End
Item	Erosion / Bank Caving			38.545022°	38.545022°	
				-121.631209°	-121.631209°	
DWR ID	DWR_ST0011_04_f_2016_17					
Comment Code						
E1 : Note and monitor erosion site.						
Inspector Comment						
It appears that the ditch is beginning to erode the landside levee toe, but is not within the levee prism. Recommend monitoring.

View of erosion at landside levee toe. Fall 2016.

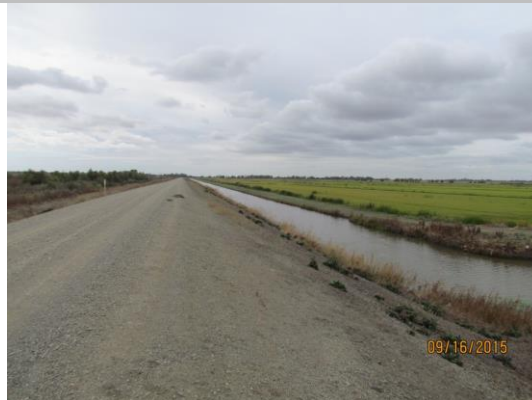
Photo 1 of 2 : FA_2018_ST0011_294_4_20180904_00002.jpg

The ditch is at the levee toe on the landward side of the levee looking downstream. Fall 2015.

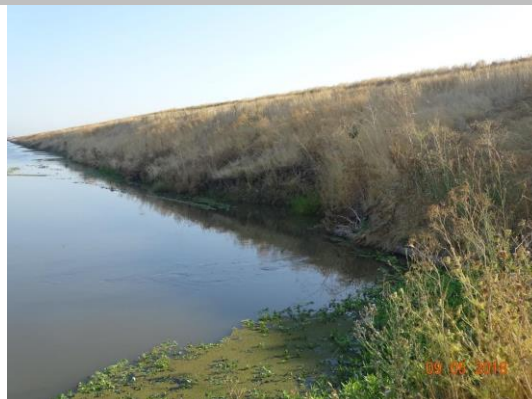
Photo 1 of 1 : FA_2018_ST0011_294_13_20180905_00018.jpg

LM Start	3.61	Rating **	M	Issue No.	13
LM End	3.61	Issue Type +	Ma	Location *	LS
Category	Earthen Levee			GPS Latitude/Longitude	
				Start	End
Item	Erosion / Bank Caving			38.523683 °	38.523683 °
				-121.631463 °	-121.631463 °
DWR ID	DWR_ST0011_04_f_2018_13				
Comment Code					
E2 : Schedule repair of erosion site prior to the next inspection.					
Inspector Comment					
Erosion on the landside toe because of irrigation canal. Sac Yard is aware of the issue and intends to fix it.

View of erosion on the landside slope adjacent to irrigation canal. Fall 2018.
